CCSD 46

**Community Consolidated School District 46
Educational Adequacy Study**

March 2023

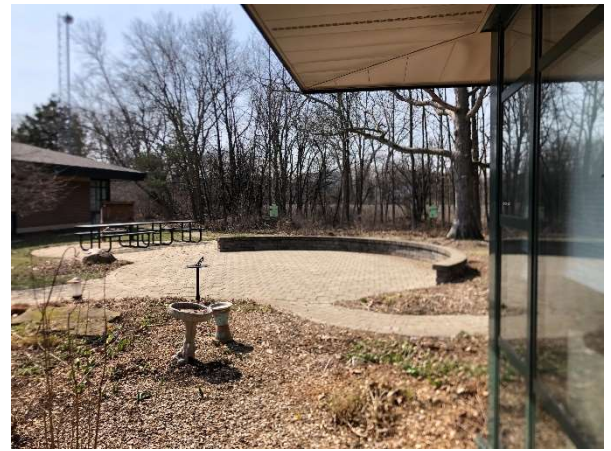
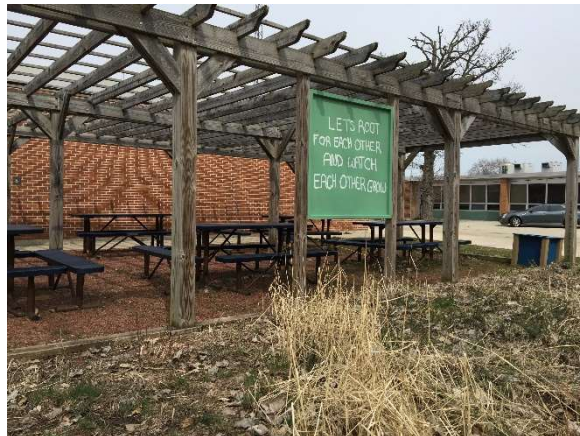
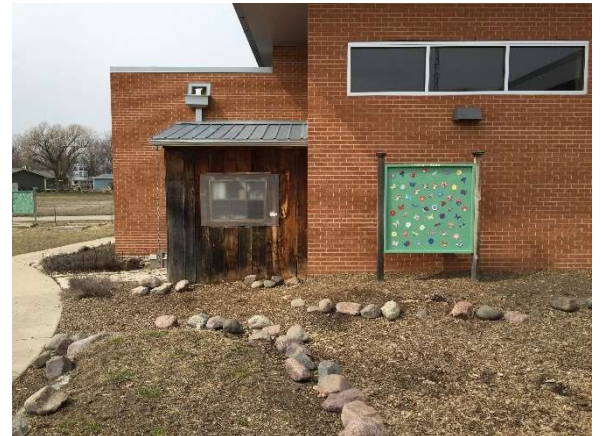
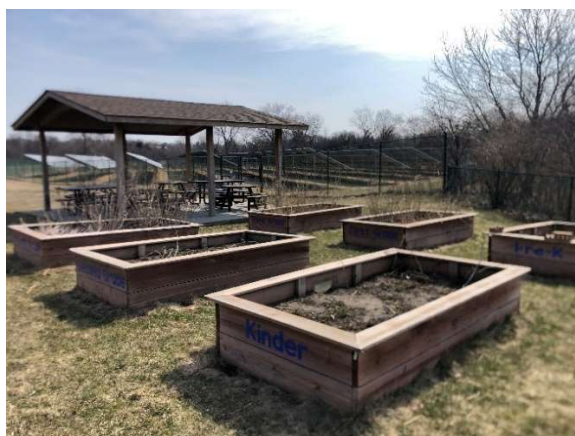
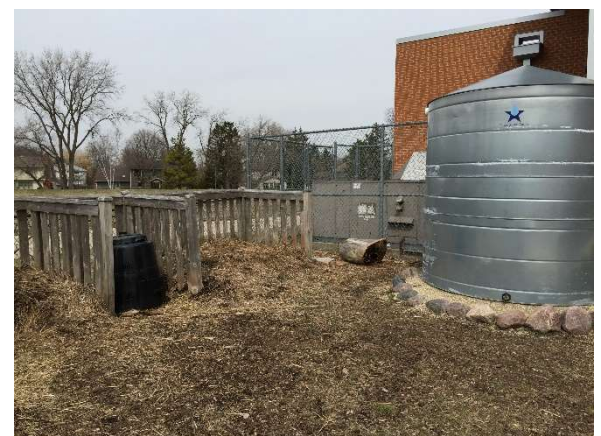
Outdoor Learning Spaces

Examples of features from Woodview, Prairieview and Meadowview

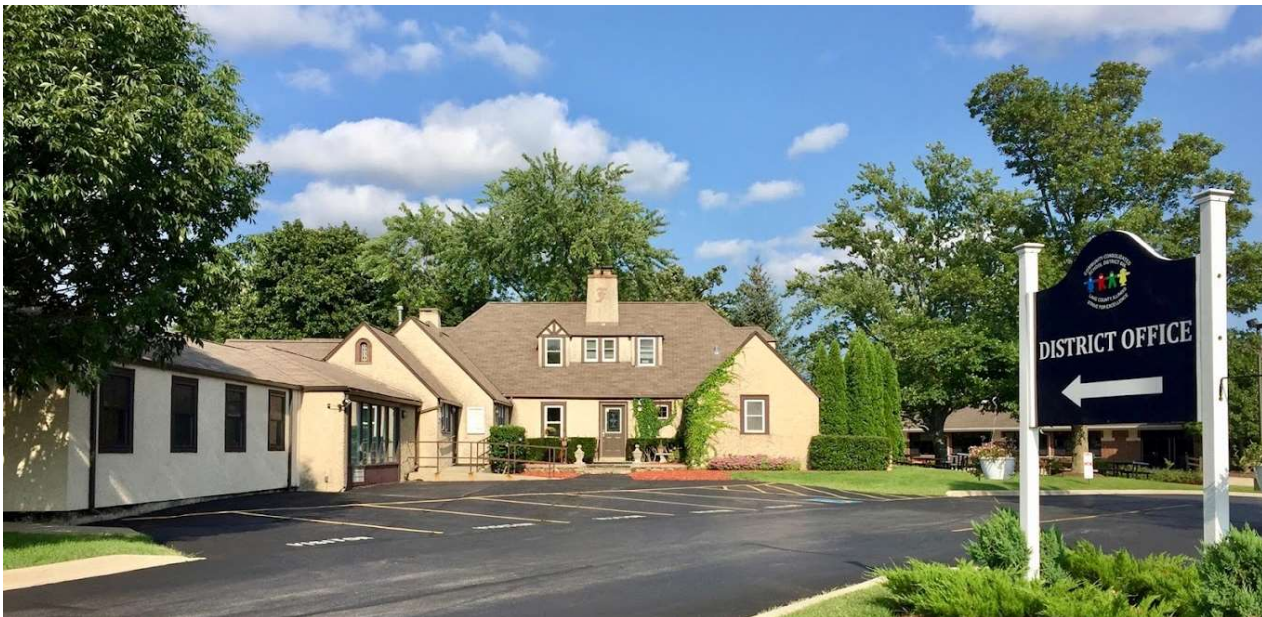
The district office building is a two-story structure with a number of additions that were added on to an original residential home. Structurally, the original home is a wood structure with stucco exterior and shingle roof. HVAC systems are not controllable centrally and are inadequate. Lightning is not at correct levels and irregular. Electrical access and technology access is limited. Exterior walls, doors, hardware, and windows are in need of life-cycle maintenance.

Functionally, the building is accessed by a ramp which is not handicap compliant and not a welcoming introduction visually to district. Access to the offices is through a small waiting vestibule. The vestibule is not ADA accessible. The reception desk does not have an adequate transaction window. The office support areas such as supply storage, mailboxes, toilet rooms, lunchroom, and general storage rooms are not adequate to support the function of the district office. The handicap accessibility throughout the building is non-compliant. Circulation and wayfinding go through tight work areas which disrupt staff. Offices doors are not lockable. The work environment is not conducive to a professional collaboration. There are no conference rooms whether they be large or small. The enclosed offices are below a planning standard in size flexibility. There is a need for more office space work areas, privacy, and support spaces to meet the staff workspace functional needs.

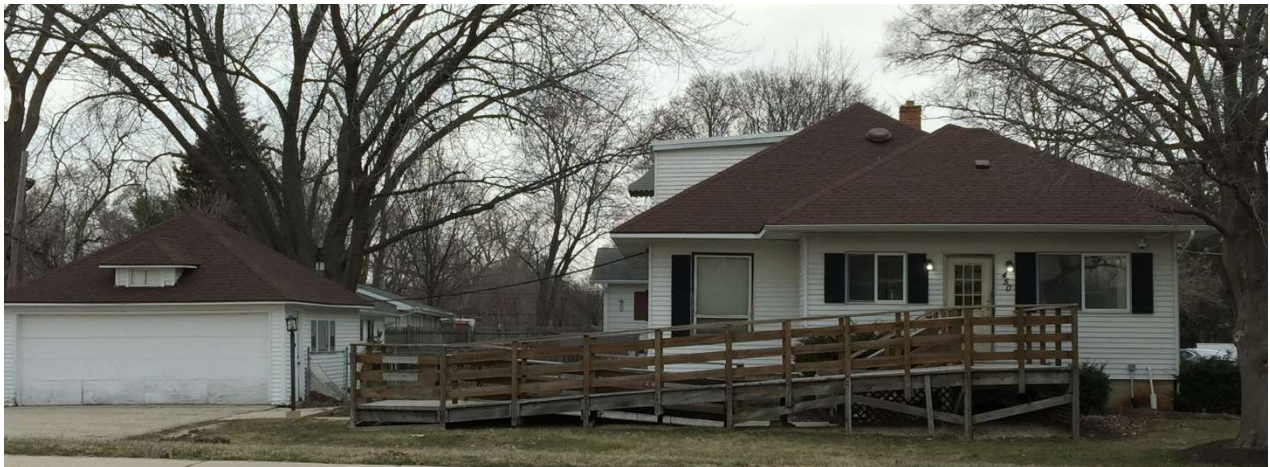
INFORMATION SERVICE CENTER

The ISC is the location of the ISC department to the east of the Grayslake Middle School parking lot. It is a previous residential home and a structure which was not adapted to the needs of the ISC department. The access to the building is via a wood ramp which is not compliant with ADA and is a fire hazard. The surrounding site is lower than the adjacent parking lot and sidewalks and prone to developing wet landscape and lawn drainage issues. Little improvements have been made to the patio or landscape areas. Landscape plantings are overgrown and need to be replaced. The site contains a garage with a non-functioning overhead door. The exterior of the building has vinyl and wood siding which is not weather tight completely around the building. Exterior windows are a mix of fixed and slider type. The exterior door is rusting. Framing around doors and windows is rotting and needs repair and painting. There are some security cameras around the perimeter. The interior of the building is original to the residential structure and needs improvement. Office finishes and irregular layout are not conducive to a professional work office environment. There is not enough electrical or data wiring to support needs of technology. Heating and cooling appear to be in functional capacity. The exterior staircase needs repair and is a fire exiting issue that needs to be resolved. Crawl space has had animals living under the structure and has since been sealed up to prevent future infestations.

The best work environment for the District Administration would be one where all functions currently located in the District Office and ISC (with the exception of Operations and Management) be located in one space based on best office practices. This would include the ability for greater collaboration, conference areas that could be used by all, Board room that could also be used as developmental learning spaces for staff, and a more appropriate interface with the community. A space program defines the approximate size of this space to be between 9,000 – 10,000 square feet. There are no current spaces within the District that could accommodate a renovation of this size. The District may consider either a lease space where the design and construction could be incorporated into the lease cost, or construction of a stand-alone building depending on land acquisition and cost.
